Manhole Inspection Summary

Manhole # S39CC1002MH

Insp Date: **12/12/06 10:23 AM**

Location Address: **760 MCKEWIN AVE**

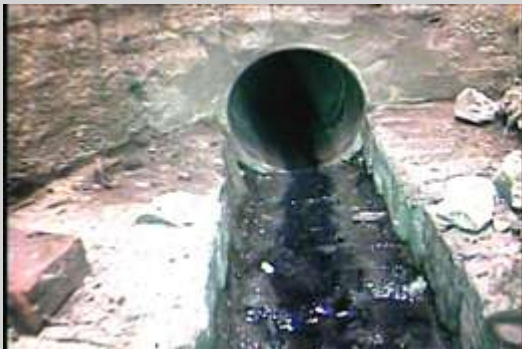
8 in. Circular Gravity Sewer Pipe In @ 5 O'Clock

Pipe Material: **Clay** ☐ Pipe Lined

Infiltration: **None** Pipe Seal Cond: **Unknown**
